MECHANICAL WORKS REPORT

Executed on GT5

Xxx [REDACTED] CITY, March 2020 – Sept 2022

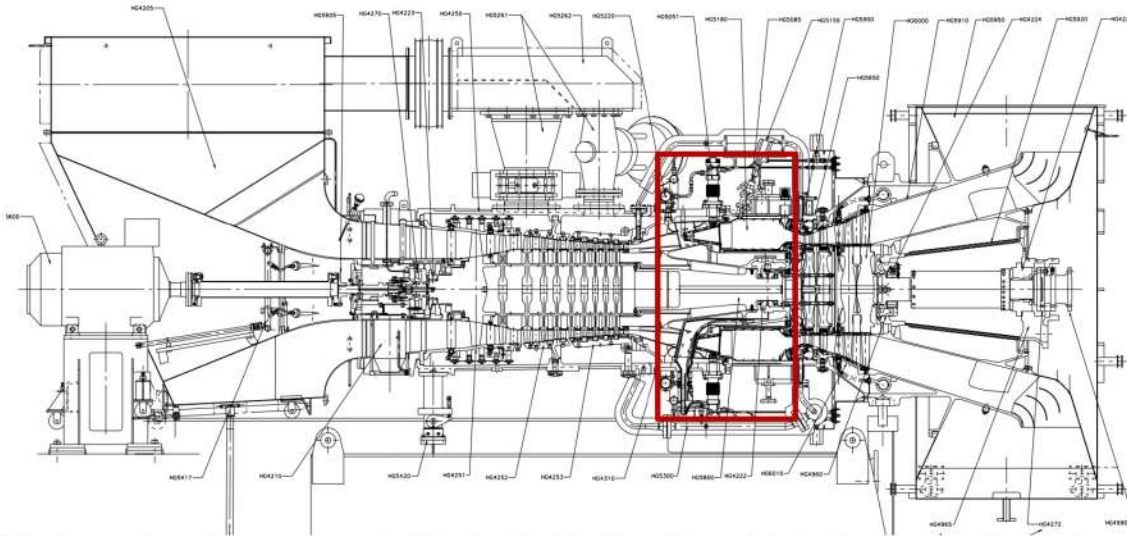
5.4. Combustion Chamber/EV Burners/Fuel Injectors/gas hoses/central casing

The damaged gas hoses were repaired. During final testing of the unit in September a small gas leakage was found at the #11 burner (connection of the main gas hose to the gas manifold). This could not be corrected by tightening, hence a gas hose from the replacement unit was installed.

The combustion chamber was replaced by a new component with latest version bypass sleeves (beer jug type). During installation of the burners it was noted that the connection of the EV cones to the burner was not correct on two positions. The manufacturer was notified and could be easily corrected on-site while the combustion chamber was installed by manufacturing a 1 meter pipe with M48 internal threads to slightly adjust the EV-cone position.

The fuel injectors were completely disassembled and cleaned. The compensators were modified as per Siemens service bulletin/Mod, which should reduce the chances of damages to the compensator. During incoming inspection of the compensators three flanges were found to be improperly positioned (not parallel). This was corrected by the supplier.

The fuel injector and combustion chamber were flow tested and orifices were adjusted by Xenerlyze. During 1st start-up a high temperature spread was noted. The assembly was therefore re-checked whilst installed. During flow testing it was quickly noted that the no 6 position burner was rotated 180 degrees causing the pilot gas connection to be connected to the main gas and vice-versa.

The combustion chamber and guide vanes were boroscoped and the error had not caused any damages to the combustion chamber or the guide vane 1 assembly.

A weld repair was performed on the ignition burner and re-installed. The ignition cable from the secondary/spare spark plug was replaced during final commissioning in September 2022 as it was found not to be functioning. During disassembly of the cable the ceramic connection came loose.

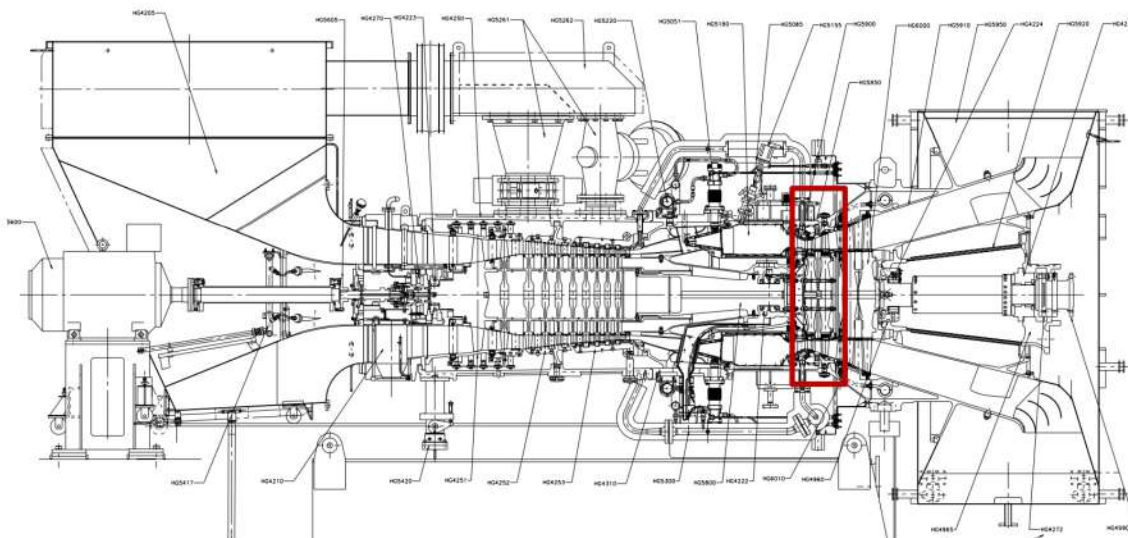
5.5. Compressor Turbine blades/vanes/disks/turbine casing

During final commissioning it was noted that the bypass system was not functioning properly causing positioning errors. Investigation revealed that the swiveling arm of the bypass actuator had been overstressed in the passed causing play on the keyway.

Additionally the no 5 position bypass valve was found to be heavy to move and replaced by a assembly from the replacement unit as a precautionary measure. The arm of the removed valve also revealed a crack.

The no 2 blades were originally replaced by new but during 1st commissioning the tip of one blade ruptured damaging the hot section down-stream.

Additionally also the Tie bolts and tie bolt nuts were replaced from the replacement unit. Reason was that two of the original tie bolts were from a different set. This was not noted during previous inspection and installation.

The bypass actuator was therefor replaced with the bypass actuator of the replacement unit. The removed bypass actuator will be repaired.

After the hot section incident the flex coupling was replaced by the coupling from the replacement unit to improve the axial and radial run-out of the turbine.

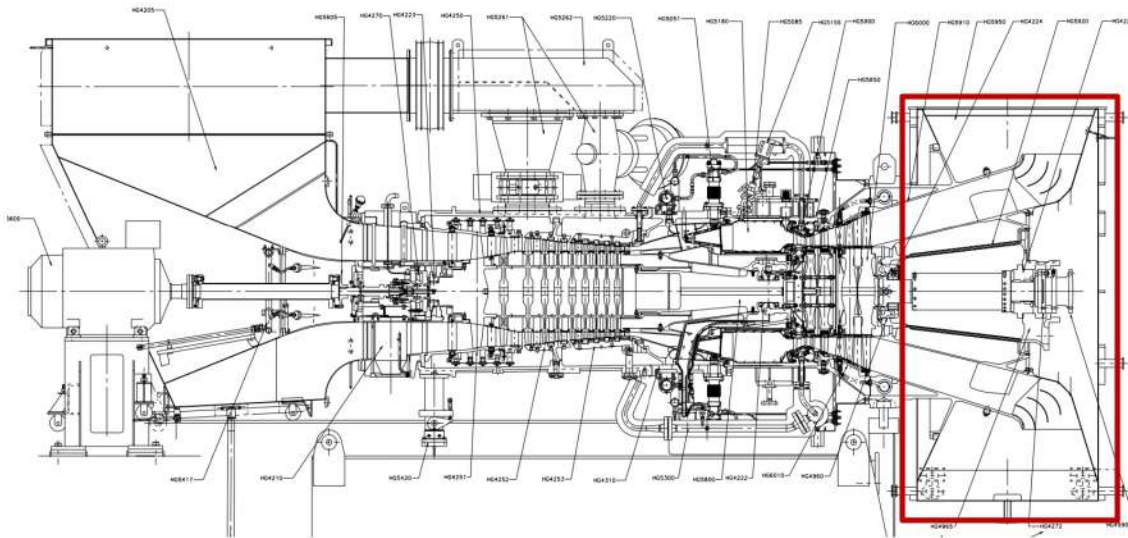
5.7. Exhaust/ PT diffusor

Cracks in the corners and flanges of the exhaust were repaired by the client. Additionally the insulation and the horizontal compensator were replaced by the client.

The broken bolts of the PT diffusor were replaced and the incorrect bolts were replaced. It should be noted that the PT diffusor is of the latest version, but that the ring installed in the exhaust has not been changed during modification. The diffusor has 1 bolt hole more than the ring. Therefore previously M10 bolts and nuts whereas M12 bolts should have been installed.

This was not corrected during the outage and was re-installed as found. In order to minimize the risk of hot air leakage a high temperature sealing compound was used on the front and rear flanges.

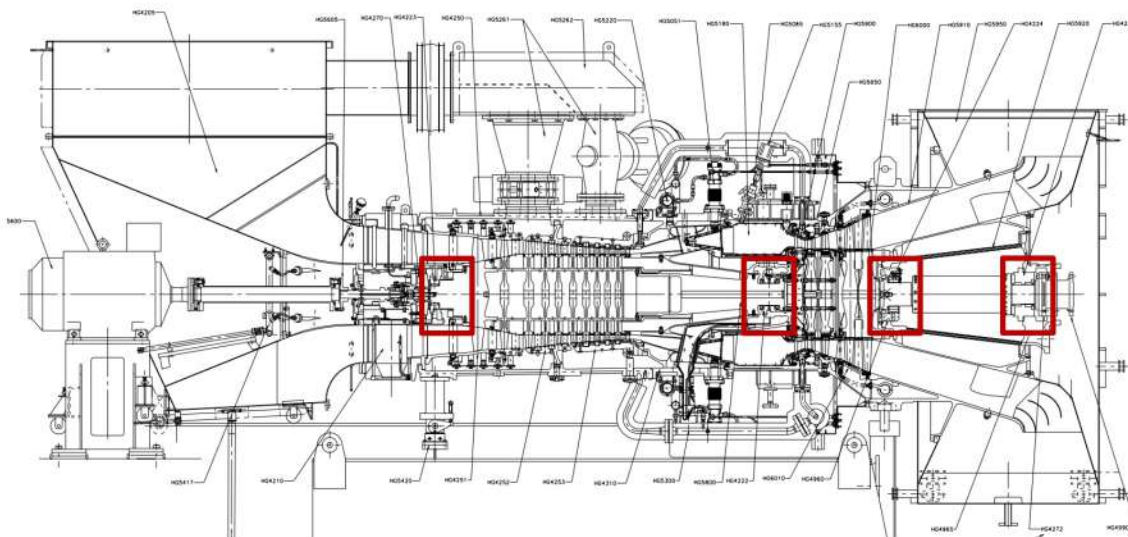
5.8. Bearings

All bearing housings were cleaned from oil coking. Oil analysis revealed that although the oil has a dark color it is still in suitable condition.

Radial bearing pads 2 and 4 and axial bearing pads 4 were replaced by new as per recommendation.
