**BYSTRONIC GLASS LINE MACHINES**

The sale of the entire line is offered.

Summary of glass line machines status

Date: 22/02/2024

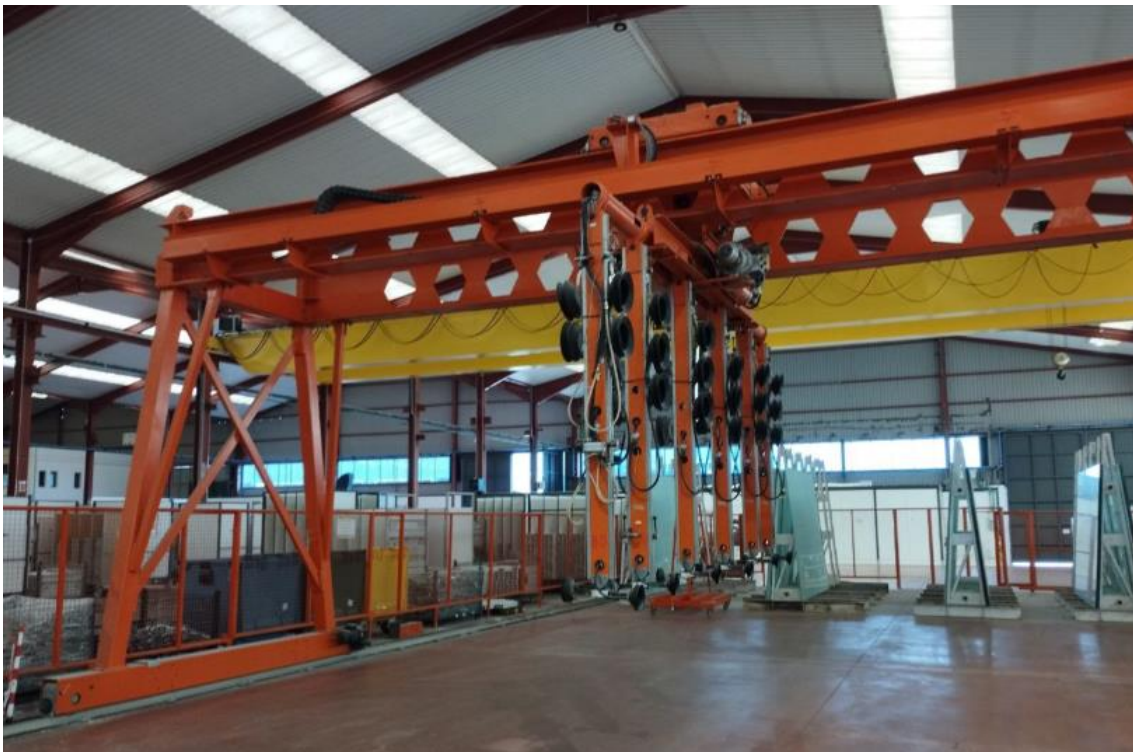
**GLASS LOADER (BYSTRONIC) – AERIAL GATEWAY**

- All movement systems work in manual mode. In automatic mode it has been tested and is positioned correctly on each of the docks with the glass plate magazines. The same thing happens with the return to the tilting table (empty).
- You are unable to pick up the iron due to a problem with the motor brake on the transverse axis of the gantry (electric or mechanical). As soon as the iron is sucked, by not braking the carriage, it moves and does not follow the vacuum suction sequence because it stops detecting the gripping position.

- Status summary:
  - 1- Manual movement functions → OK
  - 2- Automatic Operation → NOK (with glass plate) but OK without piece.
  - 3- Control Software → OK (It is a desk with buttons, without HMi panel)

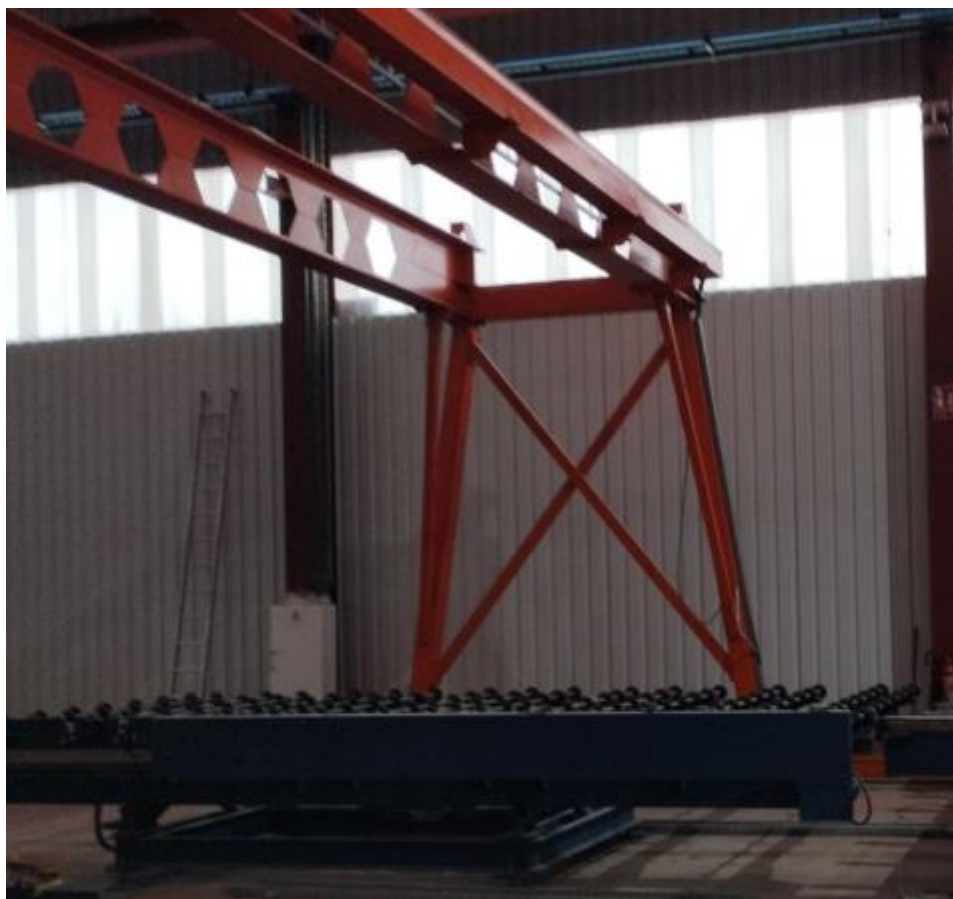
**TILT TABLE (BYSTRONIC 990337-6)**

- The movement depends on the glass loader and is done from the same control desk. It shares coordination signals between machines, so if the charger is not referenced, it does not tilt. It has been tested manually and it works. It has new rollers.

- Status Summary:
  - 1- Manual movement functions → OK (both table folding and plate extraction by rollers)
  - 2- Automatic Operation → not tested with a glass plate, because it does not have the permission signals from the loader.
  - 3- Control Software → OK (It is a desk with buttons, without HMi)

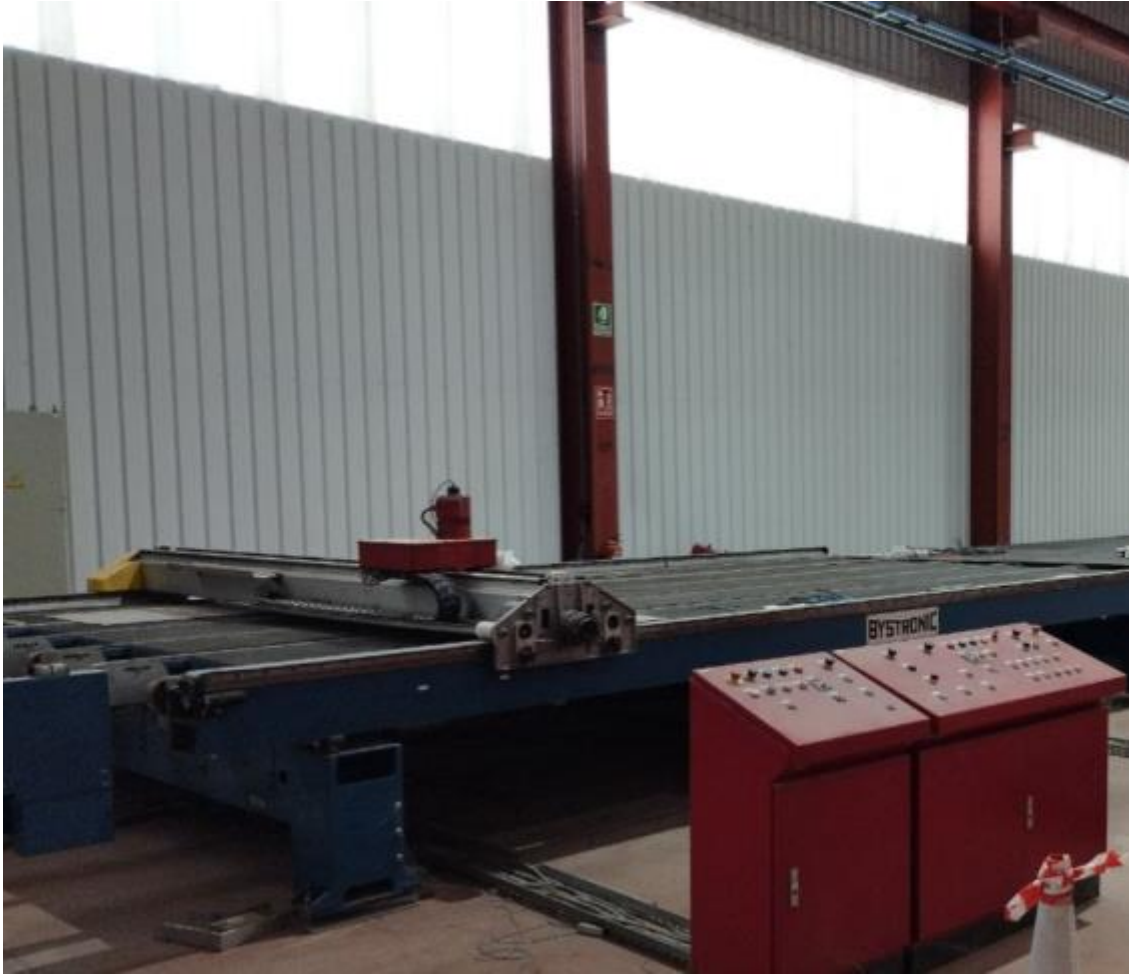
**CUTTING TABLE (BYSTRONIC)**

- It does the initial calibration correctly (reference to "0" point) and also the head movements. You have cut glass with correct measurements, configured from the Control Software (HMi). But loading any file via floppy disk from the floppy drive has not been tested (3 ½").
- There are several sizes of cutting rollers and spare parts.
- Status Summary:
  - 1- Manual movement functions → OK
  - 2- Automatic Operation → OK
  - 3- Control Software → OK (The HMi is a PC with MS-DOS operating system)

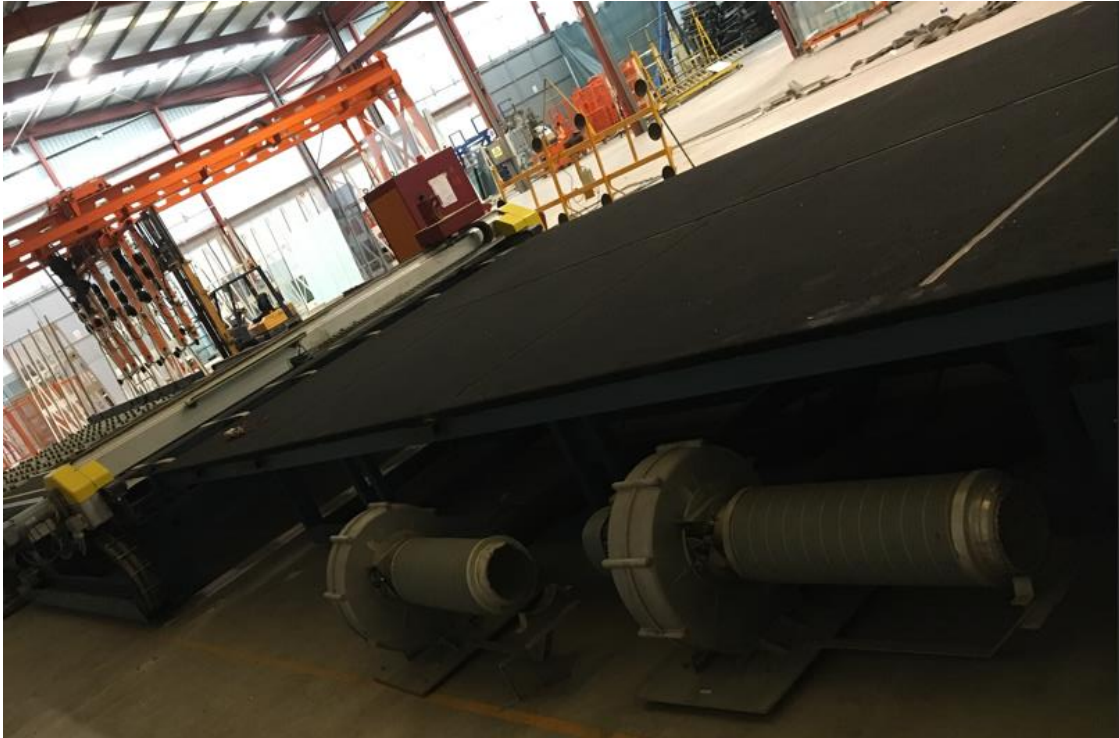
**GLASS CUT-OFF MACHINE (BYSTRONIC)**

- The control of the cylinders is done from an operator pedal next to the table (pneumatic). There are 2 cyclones that generate the air that comes out through the little holes in the table and allow the glass to be suspended in float.

- Status Summary:
  - 1- Manual movement functions → OK
  - 2- Automatic Operation → OK
  - 3- Control Software → OK (does not require HMI)

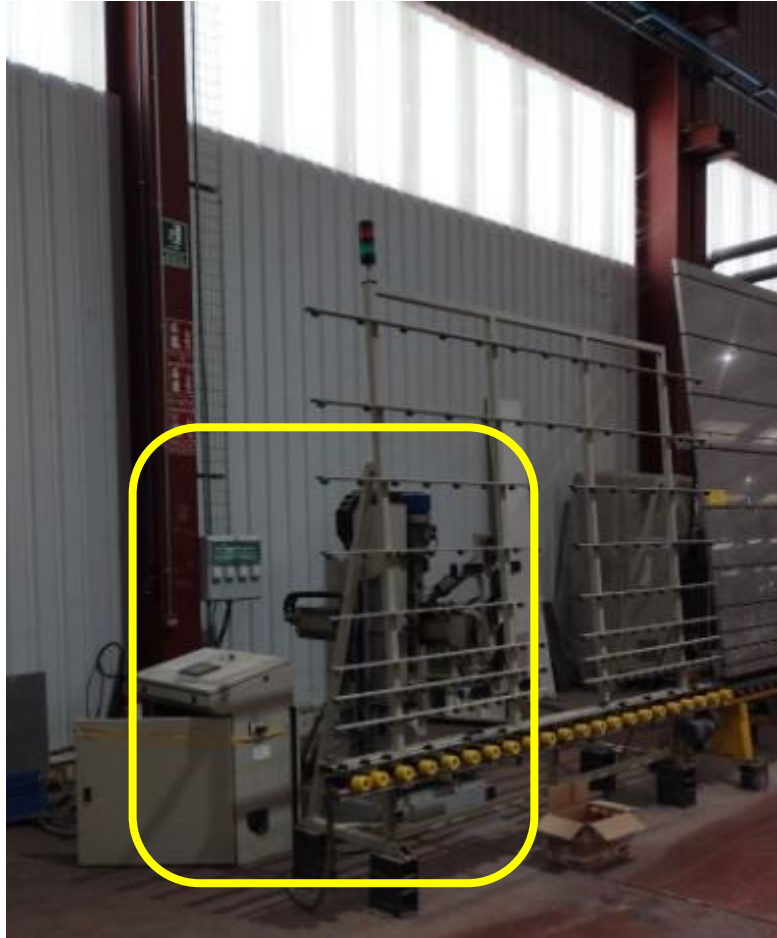
**CARGADOR LINEAL (POSICIONADOR VR 2.30 Nº 226.0727)**

- The automatic arm with suction cups would be responsible for taking each cut glass from the support (easel) and placing it on the conveyor (destined for the washing machine). But the machine came with a non-original screen because it broke down and does not work automatically. Certain sequences and configurations would have to be reprogrammed in the HMI and PLC program to readapt it. Although in manual mode with the program loaded, they move all the drives. If an original touchpanel is obtained, the original program is available to work correctly.

- Status Summary:
  - 1- Reprogram HMI screen because you need to buy the original screen if it is found and download the original program (we have got it), because right now it makes inverted movements in manual, but it does not work in automatic.
  - 2- Automatic Operation → NOK
  - 3- Control Software → OK (if you purchase an original HMI screen)

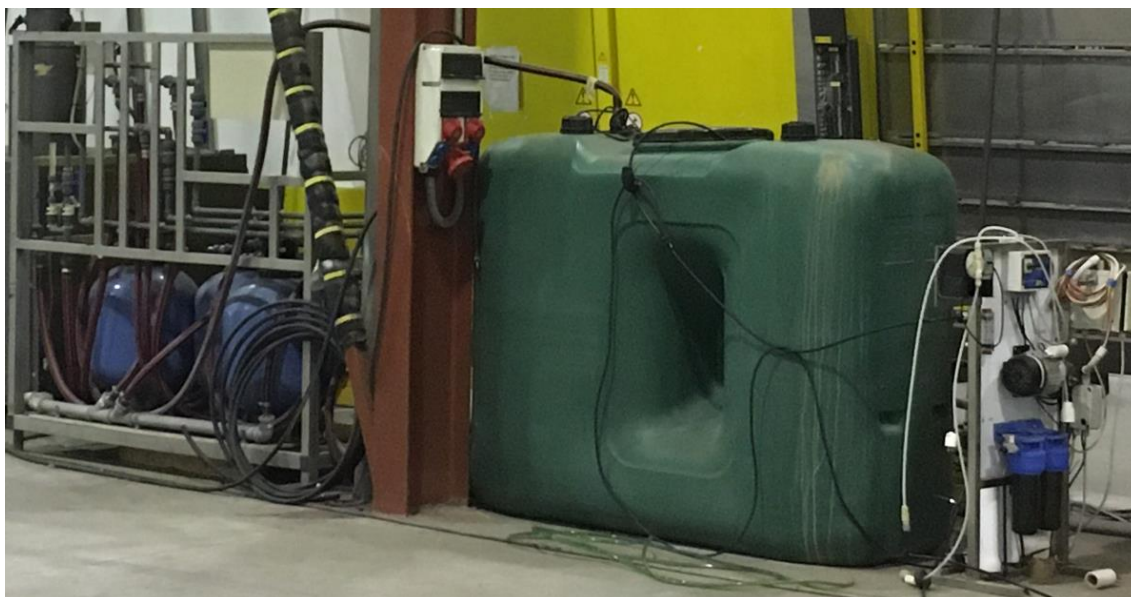
**OSMOSIS, DOSING AND FILTRATION PLANT**

- Both the generation of osmosis water from mains water and the treatment by dosing the washing product with algaecide work correctly. Filtration also works using sand filters and their respective recirculation and impulsion pumps.

- Status Summary:
  - 1- Manual movement functions → OK
  - 2- Automatic Operation → OK
  - 3- Control Software → OK (does not require HMI)

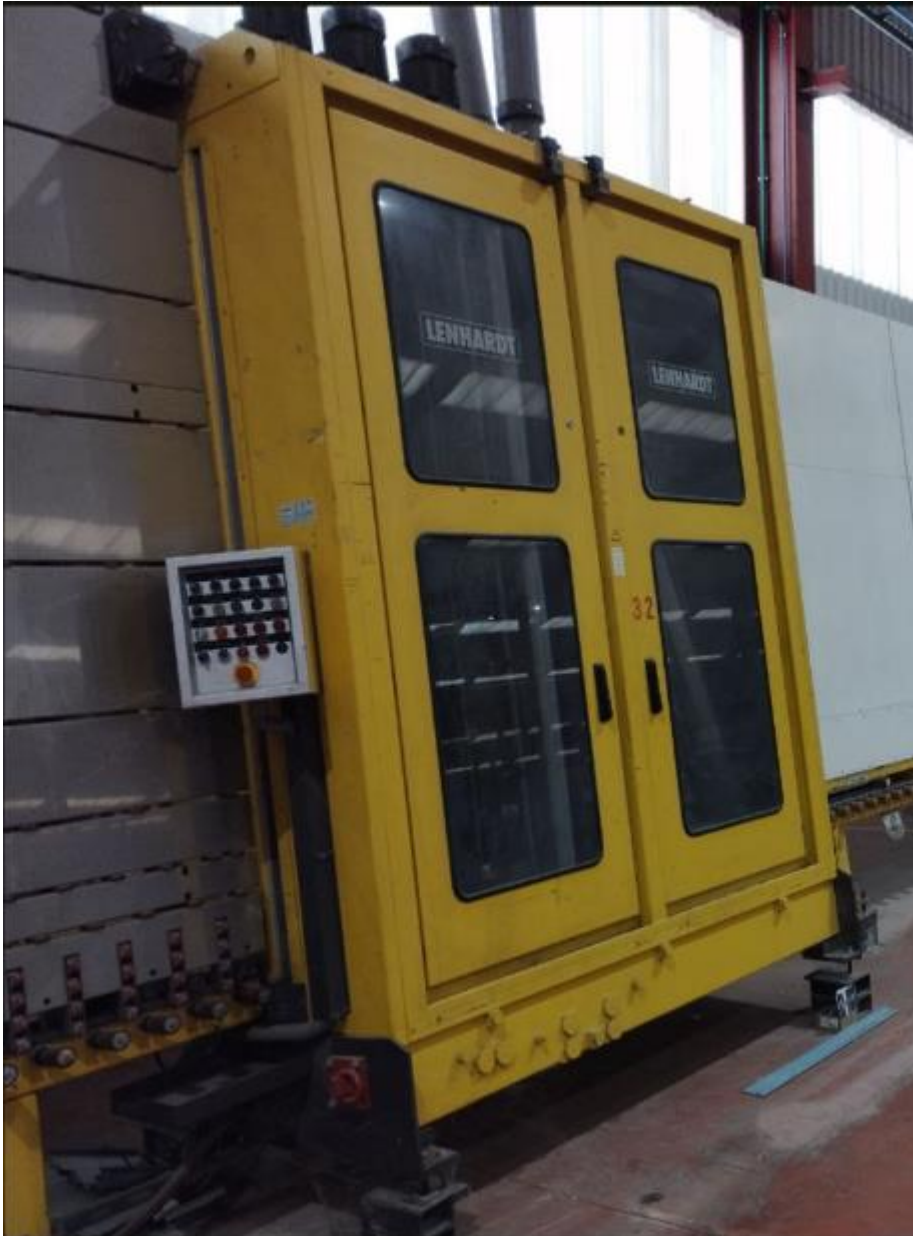
**WASHING MACHINE (LENHARDT)**

- It is composed of:
  - o Entrance transport to washing machine TB BR 2.70 1.70 VL 1AS N° 231.1505
  - o Inlet transport to washing machine TB BR 2.70 2.50 VL 1AS N° 231.1396
  - o Washing machine GW D 2.30 0.00 VL 3B15 No. 251.0419
  - o Transport stand TB LK 2.50 3.70 VL 2AS N° 212.1439
- Dirty glass has been tested and washed and dried correctly. However, the rear door seals need to be replaced because they are cracked and leaking water.
- Status Summary:
  - 1- Manual movement functions → OK
  - 2- Automatic Operation → OK
  - 3- Control Software → OK (panel with buttons, without HMI)

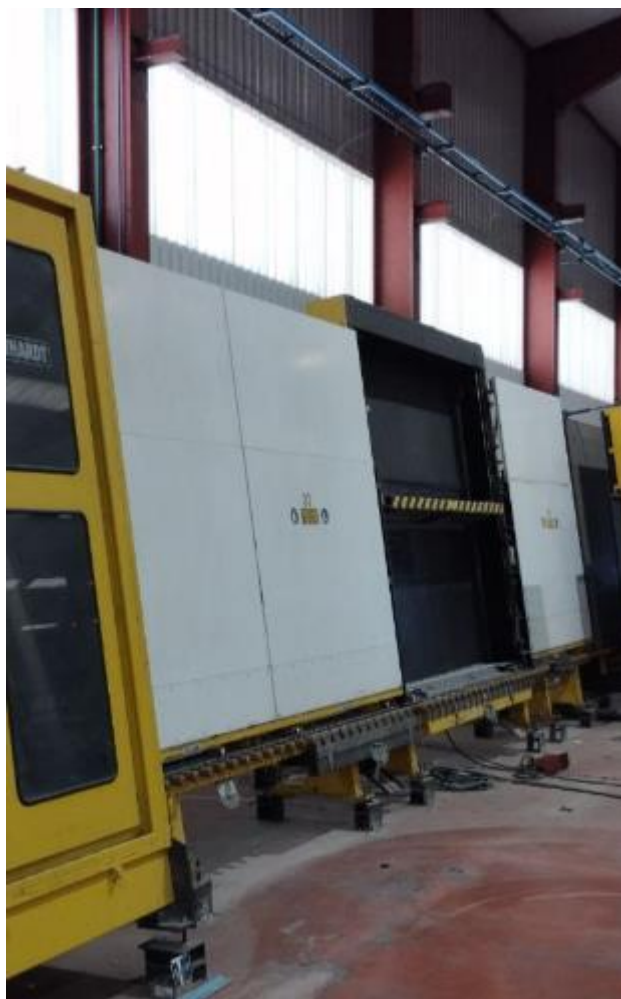
**GLASS INSPECTOR (VR 2.30 2.90 VL OP 1AS inspection station No. 226.0727)**

- Glass has been passed and both glass detection with specific presence sensors (glass cells) and transportation to the next station works. The lighting works too.

- Status Summary:
  - 1- Manual movement functions → OK
  - 2- Automatic Operation → OK (the interpretation is by the operator)
  - 3- Control Software → OK (does not require HMI)

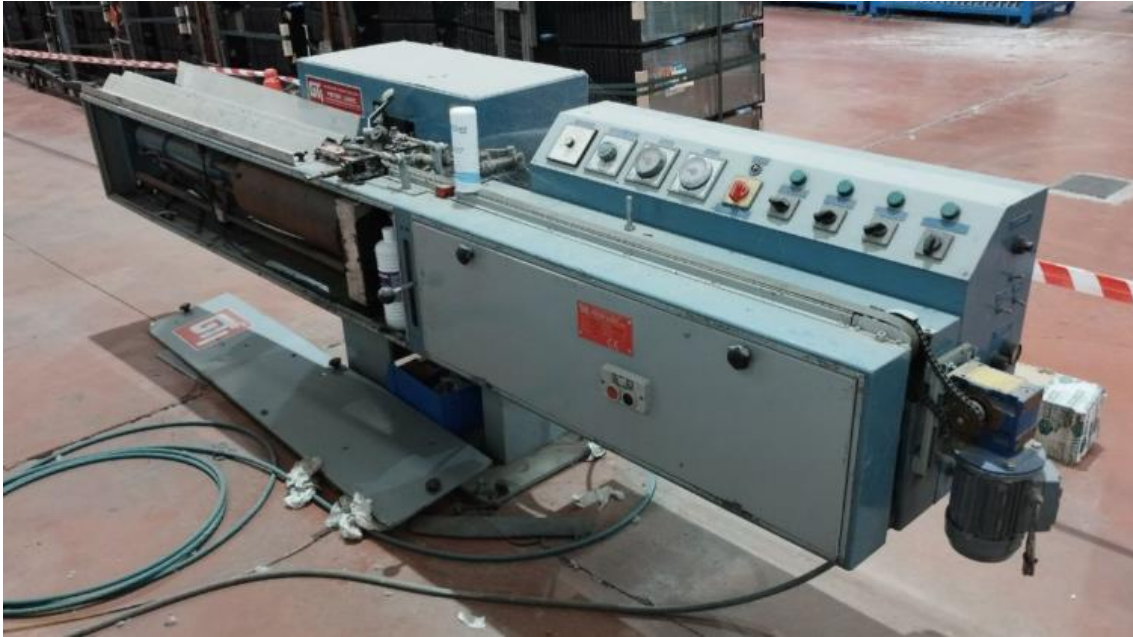
**GLASS SEALING DISPENSER (BUTYL)**

- It is a simple machine in which all the elements work, but it needs a thorough general cleaning, because the product and the started cartridge were left for a long time.
- After cleaning, it requires mechanical dosage adjustment according to the mixture and product used.

- Status Summary:
  - 1- Manual movement functions → OK
  - 2- Automatic Operation → Not tested because it has not been cleaned
  - 3- Control Software → OK (does not require HMI)

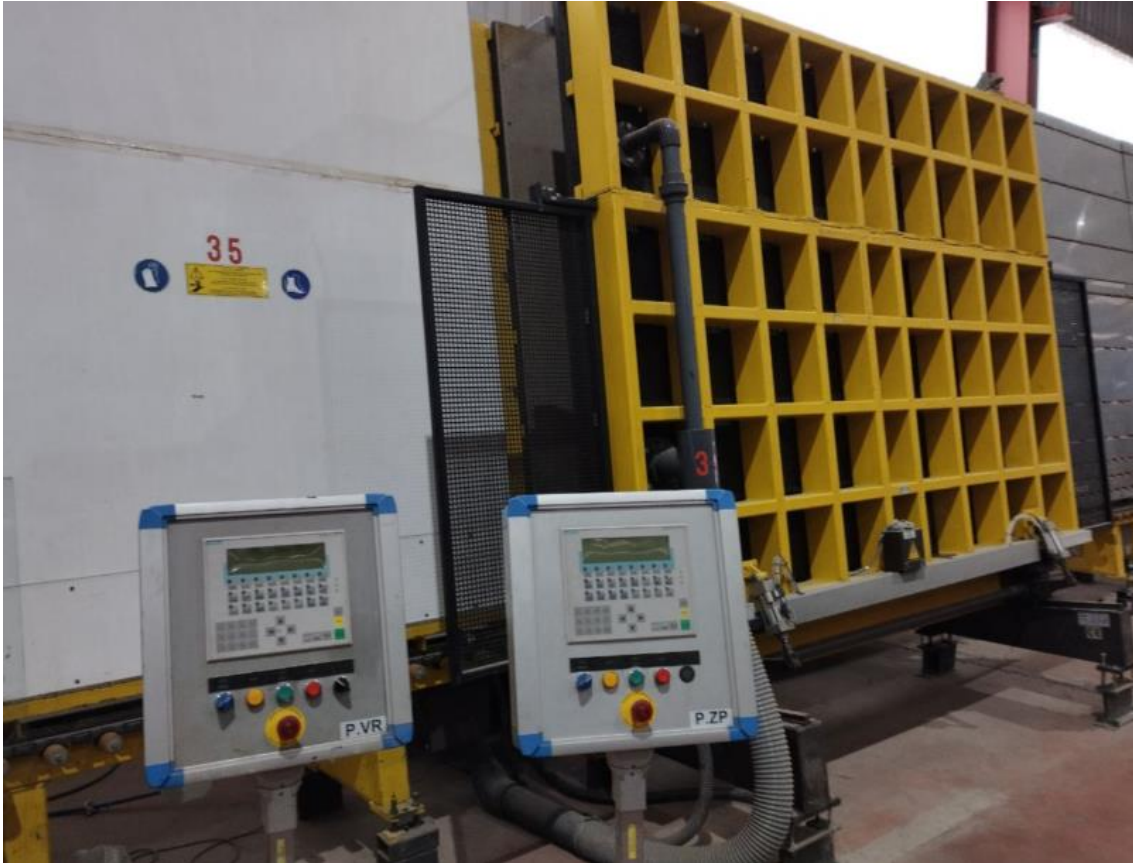
**FLAT PRESS (ZP 2.30 N° 234.0517)**

- It is composed of:
  - Transport stand with measuring system TB LK 2.50 2.10 VL 1AS N° 212.1423
  - Flat Press ZP 2,30 3,10 VL SP 1AS N° 234.0517
  - Transport stand TB BR 2,70 2,50 VL 1AS N° 212.1451

- Transport stand TB BR 2,70 0,90 VL 1AS N° 212.1452
- The operator has to insert the first glass by hand and then has to glue the frame at this point to the 2nd glass of the sandwich and when it enters the press, he vacuums the first and takes it (operator's side) and then passes the 2nd with the frame stuck and the one behind it sucks it. Then he lines them up and glues them together with pressure.

- It has two control desks for this (with screen) where all the recipes of the different references are configured, to control the actual tightening value (after having previously measured the thickness of the sandwich). One at the beginning and one at the end.

- Status Summary:
  - 1- Manual movement functions → OK
  - 2- Automatic Operation → Not tested.
  - 3- Control Software → Both HMi operator panels works properly.

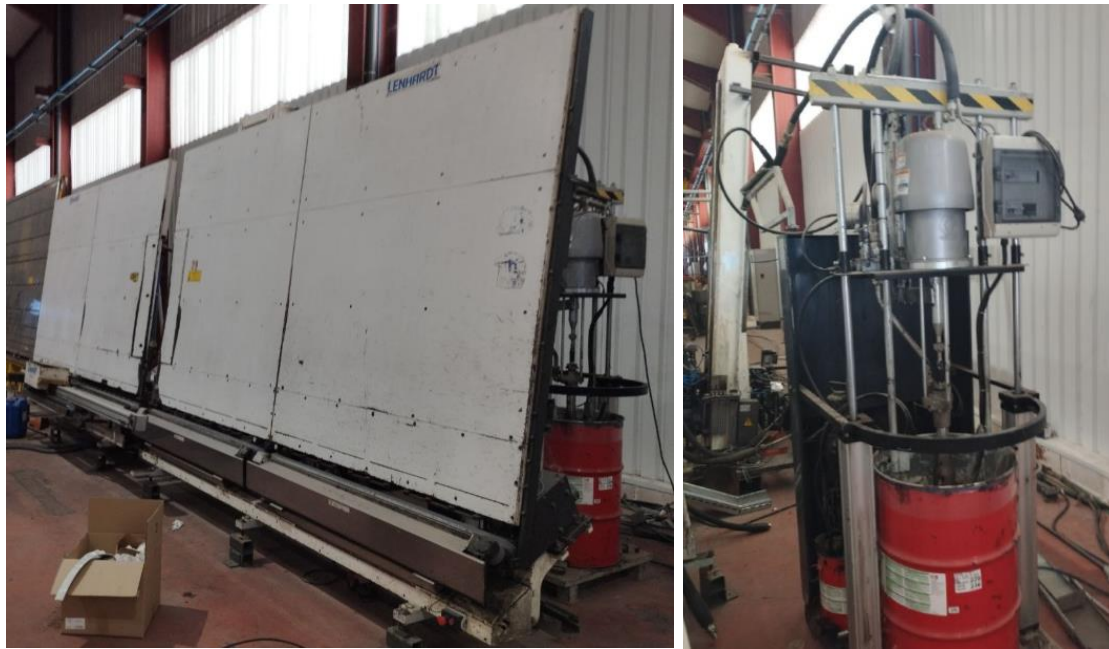
**SEALING MACHINE (LENHARDT - VA 1K-V 2,30 3,80 VL REC PU N° 233.0421)**

- It is the one that dispenses the sealing paste along the edges of the glass sandwich.
- The manual movements of each movement unit work, but the usage parameters have not been configured because no putty has been drawn through the nozzle. The machine manages to successfully carry out the automatic calibration sequence of the axes that it initially performs.
- Requires thorough cleaning of the entire dosing circuit.
- The PC touch screen is damaged. A monitor has been connected from the outside and a mouse to replace it.

- Status Summary:
  - 1- Manual movement functions → OK
  - 2- Automatic Operation → Not tested.
  - 3- Control Software → It has a PC with OS Windows XP.
